# **CORROSION OF FUSION-BONDED EPOXY COATED BARS IN CHLORIDE-CONTAMINATED PLAIN AND SILICA FUME CEMENT CONCRETES EXPOSED TO VARYING TEMPERATURE**

**A. S. Al-Gahtani and M. Maslehuddin**

King Fahd University of Petroleum and Minerals  
Dhahran, Saudi Arabia

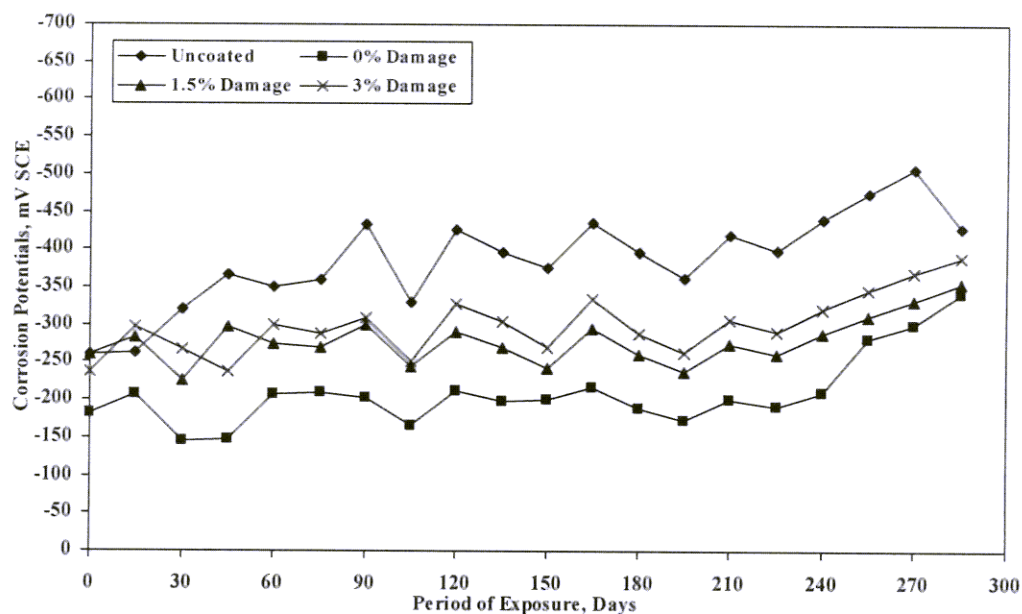
Fig. 1: Corrosion Potentials on uncoated and FBEC steel bars in Plain Cement Concrete Specimens (Exposure Temp: 25 °C).

The time-corrosion potential curves for steel in plain and silica fume cement concrete specimens exposed to temperatures of 25 °C, 35 °C and 48 °C are shown in Figures 1 through 6. Figure 1 shows the corrosion potentials of steel in the plain cement concrete specimens exposed to a temperature of 25 °C. The corrosion potentials decrease, i.e., become more negative with time and the corrosion potentials on the uncoated steel bars are more negative than those on the FBEC steel bars.

The corrosion potentials depicted in Figures 1 through 6 were utilized to assess the time to initiation of reinforcement corrosion according to ASTM C 876 criteria. These data are summarized in Table 1. The data in Table 1 indicate that the time to initiation of reinforcement corrosion was influenced by the exposure temperature, extent of surface damage and the cement type. The time to initiation of corrosion decreased with the extent of surface damage and increasing exposure temperature. Further, corrosion initiation was noted later in the silica fume cement concrete specimens compared to the plain cement concrete specimens.

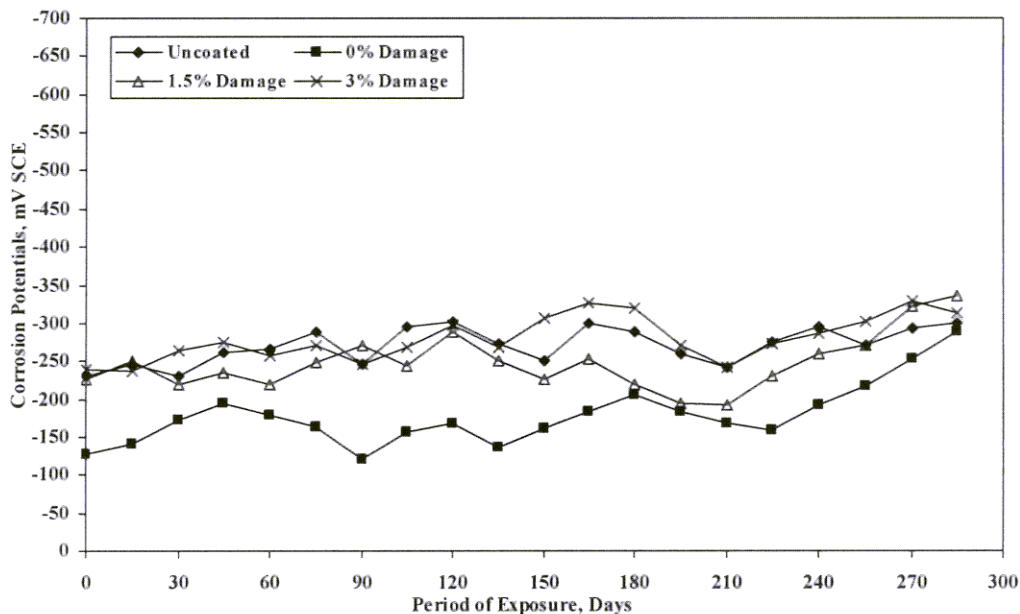
Fig. 2: Corrosion Potentials on uncoated and FBEC steel bars in the Silica Fume Cement Concrete Specimens (Exposure Temp: 25 °C).

Figure 2 shows the corrosion potentials on steel in the silica fume cement concrete specimens exposed to a temperature of 25 °C. The corrosion potentials were maximum (more positive) on the FBEC steel bars without any damage while those on the FBEC bars with 1.5% and 3% damage were marginally more positive than the uncoated steel bars.

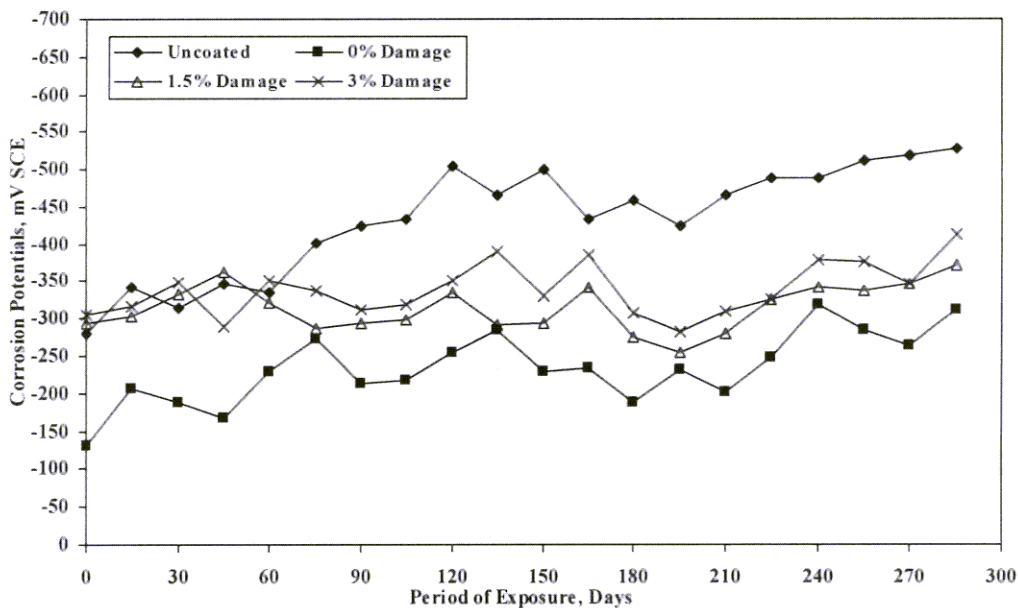
Fig. 3: Corrosion Potentials on uncoated and FBEC steel bars in the Plain Cement Concrete Specimens (Exposure Temp: 35 °C).

Figure 3 shows the corrosion potentials on steel bars in plain cement concrete specimens exposed to a temperature of 35 °C. The potentials were low (less negative) on the uncoated steel bars while they were the highest (more positive) on the undamaged FBEC steel bars. The corrosion potentials on all the steel bars decreased with the time of exposure. The corrosion potentials on steel in the silica fume cement concrete specimens exposed to a temperature of 35 °C are shown in Figure 4. The potentials were more negative on the uncoated steel bars while they were more positive on the undamaged FBEC steel bars. The potentials on FBEC steel bars with

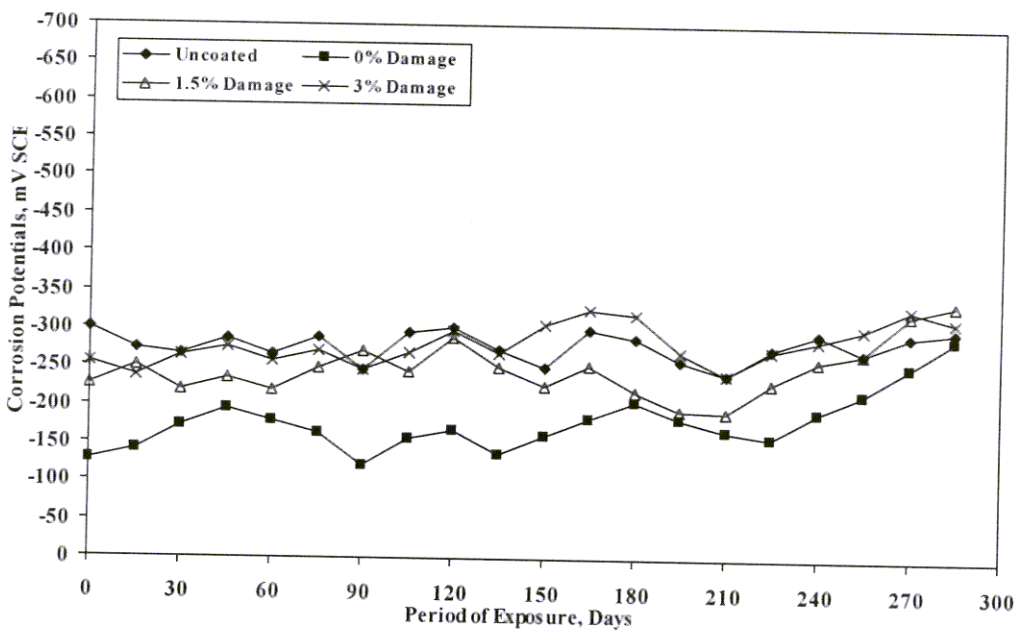
Fig. 4. Corrosion Potentials on Uncoated and FBEC steel bars in the Silica Fume Cement Concrete Specimens (Temp: 35 °C).

1.5% and 3% damage tended to be between potential values for uncoated and undamaged FBEC steel bars.

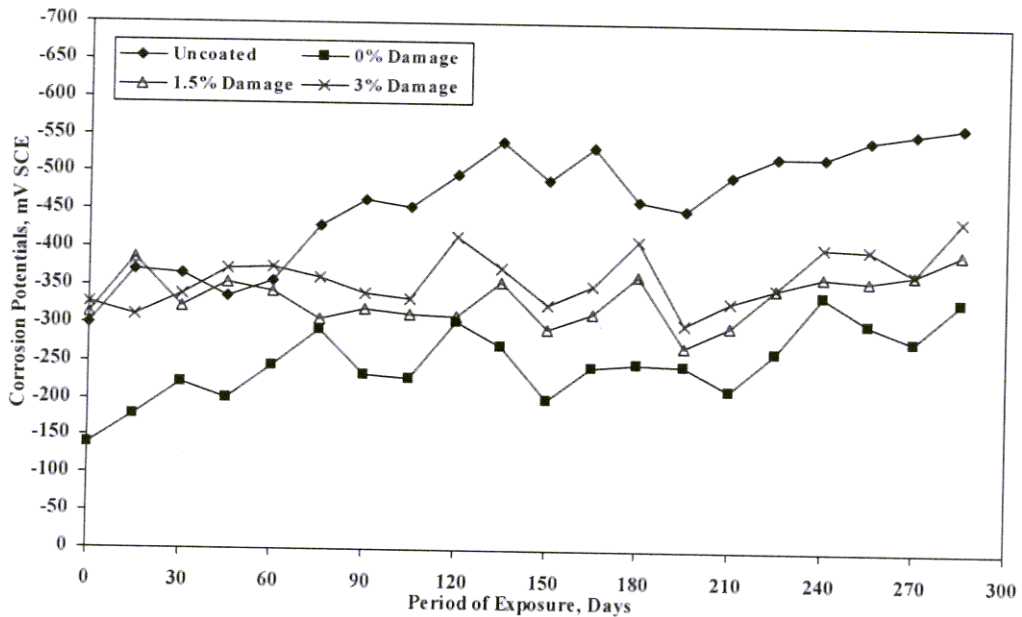
Fig. 5. Corrosion Potentials on Uncoated and FBEC steel bars in the Plain Cement Concrete Specimens (Temp: 48 °C).

Figures 5 and 6 show the corrosion potentials on the uncoated and FBEC bars in the plain and silica fume concrete specimens exposed to a temperature of 48 °C. As expected, the corrosion potentials on the uncoated steel bars were more negative than those on the FBEC steel bars.

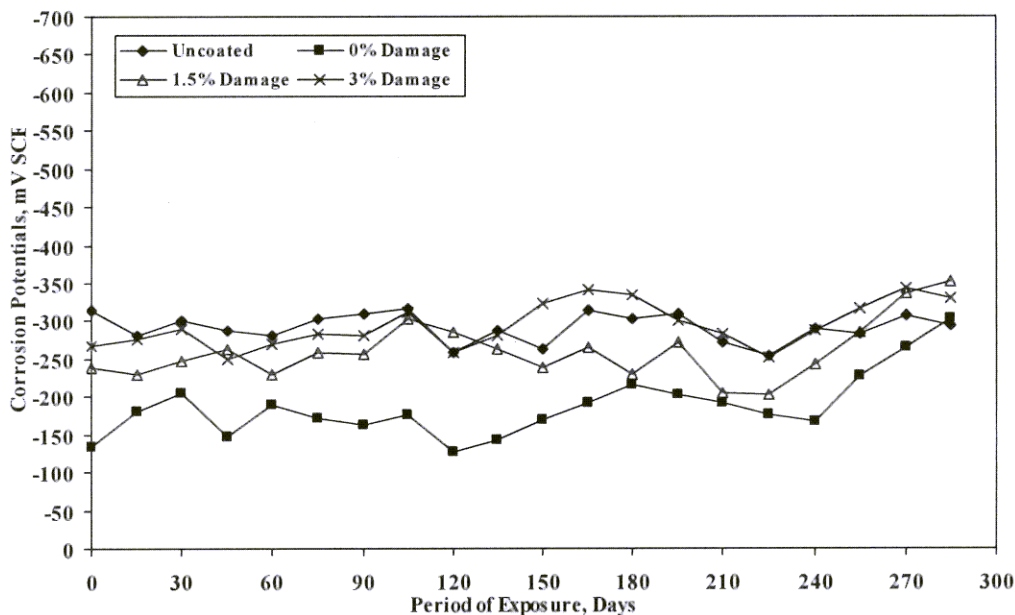
Figure 6: Corrosion Potentials on Uncoated and FBEC steel Bars in the Silica Fume Cement Concrete Specimens (Temp: 48°C).

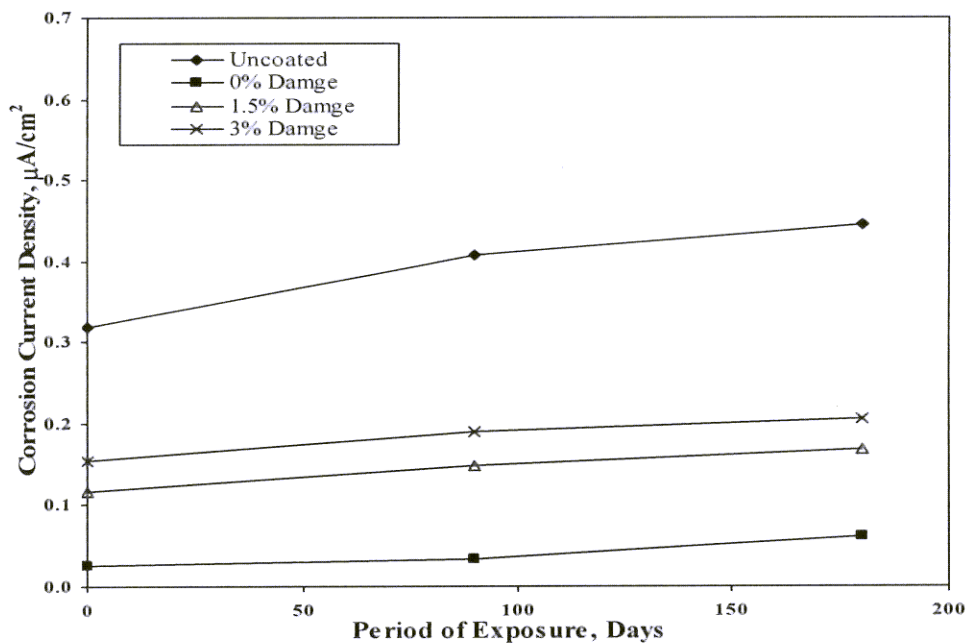
Figure 7: Corrosion Current Density on steel in the Plain Cement Concrete Specimens exposed to 25 °C.

The variation of corrosion current density,  $I_{\text{corr}}$ , with time on the uncoated and FBEC steel bars in the plain and silica fume cement concrete specimens exposed to 25, 35, and 48 °C temperature is depicted in Figures 7 through 12. The values at each age are the mean of measurements conducted on three similar specimens.

Figures 7 and 8 depict the  $I_{\text{corr}}$  values on steel in the plain and silica fume cement concrete specimens exposed to a temperature of 25 °C. The data in these figures show that the  $I_{\text{corr}}$  increases with time. The  $I_{\text{corr}}$  was generally less in the concrete specimens with FBEC steel bars.

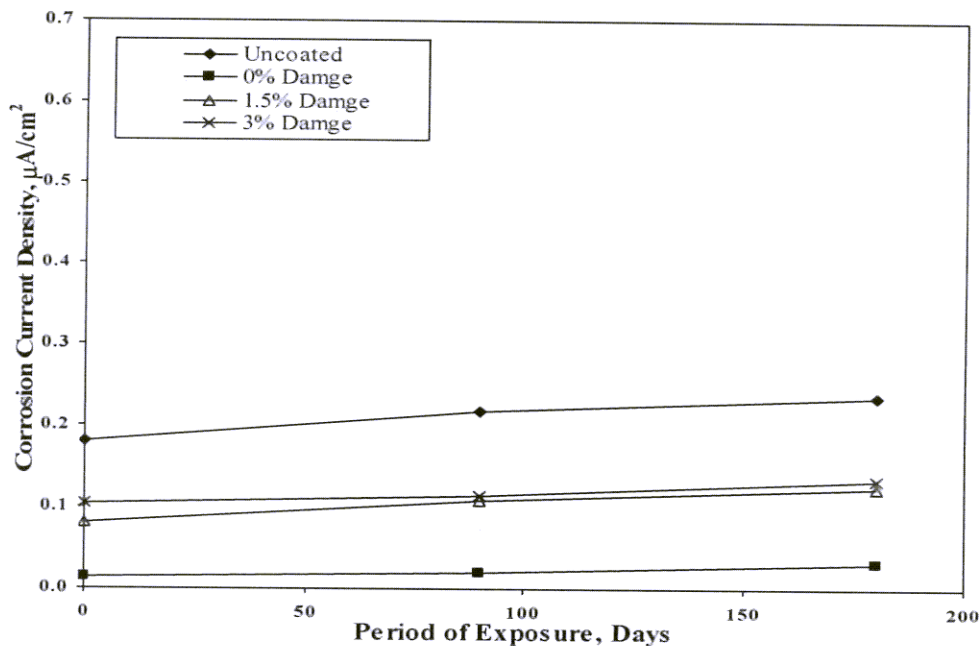
Figure 8: Corrosion Current Density on Steel in the Silica Fume-Cement Concrete Specimens exposed to 25 °C.

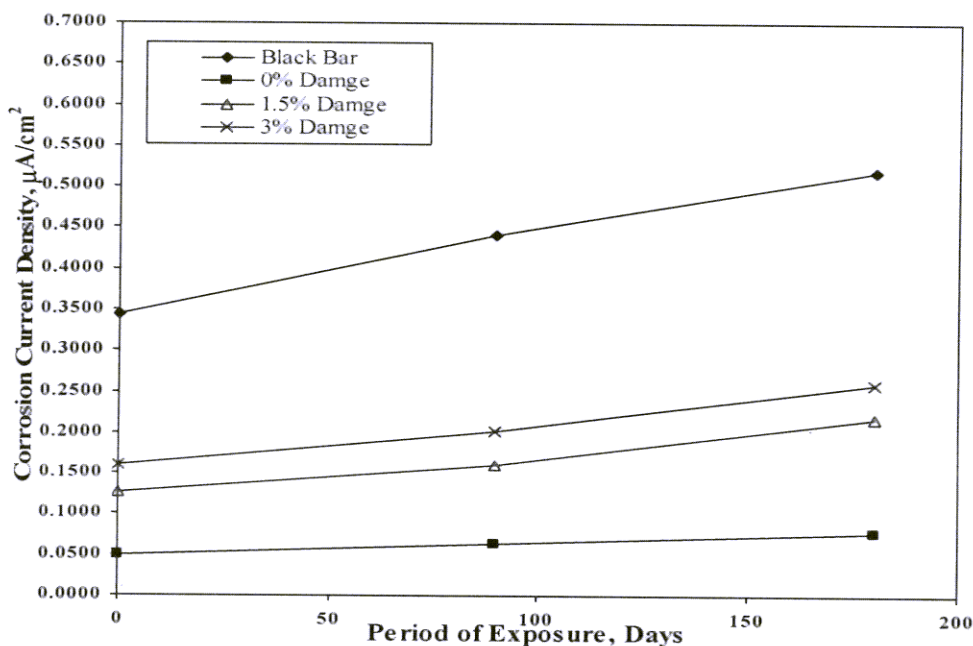
Figure 9: Corrosion Current Density on Steel in the Plain Cement Concrete Specimens exposed to 35 °C.

Figure 9 shows the  $I_{\text{corr}}$  values on steel in plain cement concrete specimens exposed to a temperature of 35 °C. The  $I_{\text{corr}}$  was generally the least on FBEC steel bars with a value less than 0.1  $\mu\text{A}/\text{cm}^2$ . The  $I_{\text{corr}}$  values on the uncoated bars was more than 0.3  $\mu\text{A}/\text{cm}^2$  from the initial period of exposure. The  $I_{\text{corr}}$  in all the specimens increased with the time of exposure. The  $I_{\text{corr}}$  on steel in the silica fume cement concrete specimens exposed to a temperature of 35 °C is depicted in Figure 10. The  $I_{\text{corr}}$  was the least in FBEC steel bars it was the maximum on the uncoated bars. The  $I_{\text{corr}}$  on FBEC steel bars with 1.5% and 3% damage tended to be between that of the uncoated and FBEC bars. In all the specimens, the  $I_{\text{corr}}$  value was less than 0.3  $\mu\text{A}/\text{cm}^2$  indicating better resistance to corrosion.

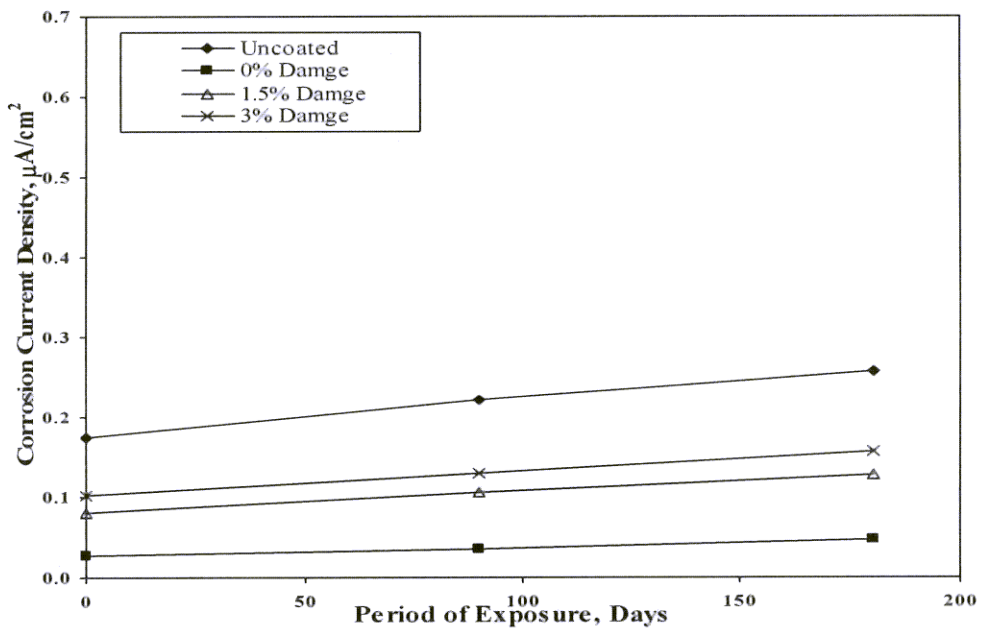
Figure 10: Corrosion Current Density on Steel in the Silica Fume Cement Concrete Specimens exposed to  $35^\circ\text{C}$ .

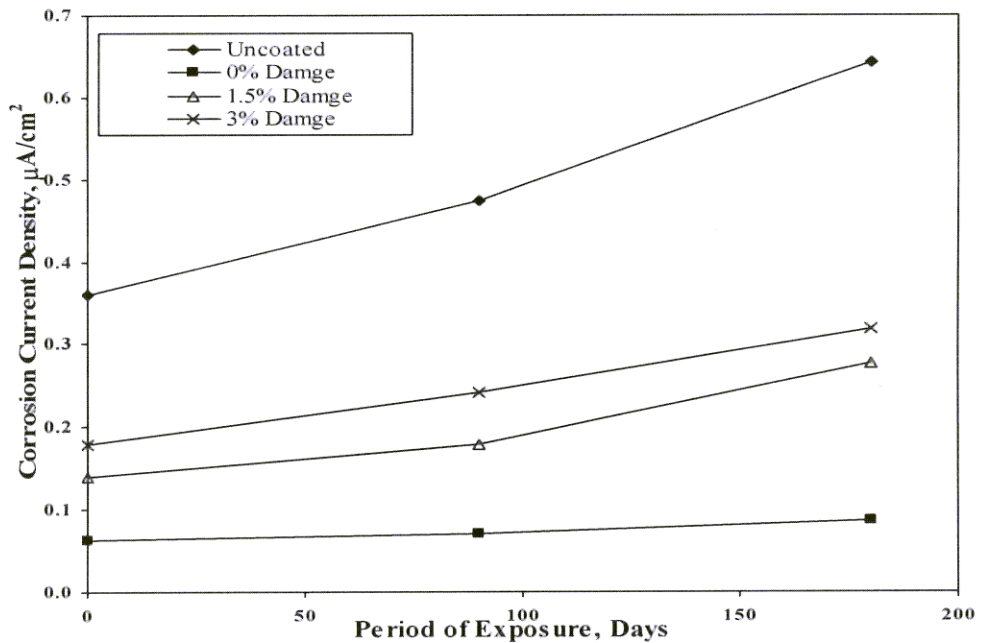
Figure 11: Corrosion Current Density on Steel in the Plain Cement Concrete Specimens exposed to  $48^\circ\text{C}$ .

Figure 11 shows the  $I_{\text{corr}}$  values on steel in plain cement concrete specimens exposed to a temperature of 48 °C. As expected, the  $I_{\text{corr}}$  on the uncoated steel bars was more than that on the FBEC steel bars. The corrosion current density was more than 0.3  $\mu\text{A}/\text{cm}^2$  from initiation of exposure itself. The  $I_{\text{corr}}$  in the undamaged FBEC steel bars was less than 0.3  $\mu\text{A}/\text{cm}^2$ . The  $I_{\text{corr}}$  on steel in the silica fume cement concrete specimens exposed to a temperature of 48 °C is shown in Figure 12. The trend of these data was similar to that noted on the specimens exposed to 35 °C. However, the  $I_{\text{corr}}$  in the specimens exposed to 48 °C was more than that in the specimens exposed to 35 °C.

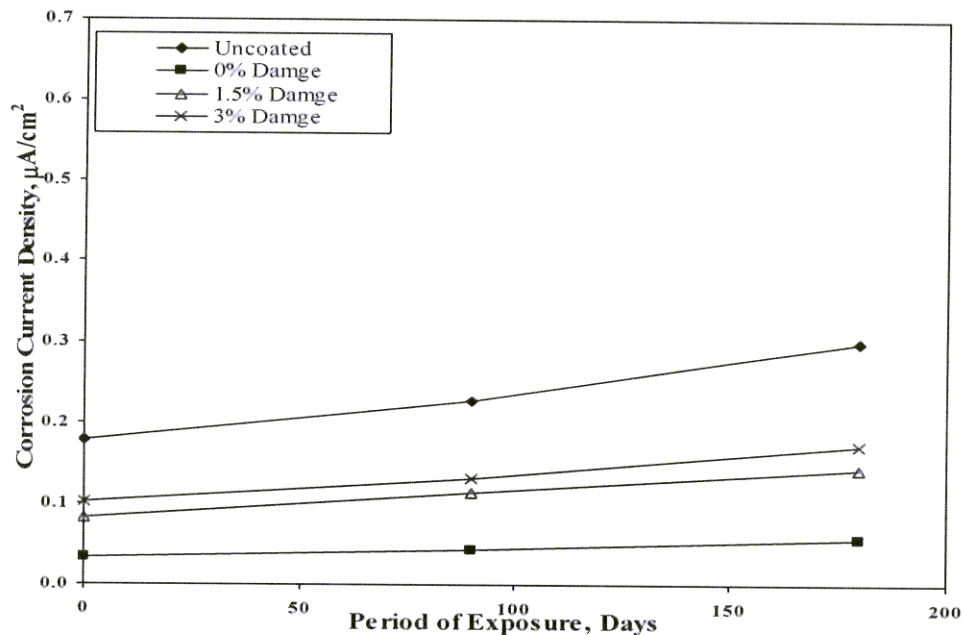
Figure 12: Corrosion Current Density on steel in the Silica Fume Cement Concrete Specimens exposed to 48 °C.
